✓
AFML-TR-72-30

INSTALLATION OF A SELF-SEALING MATERIALS
SYSTEM IN A C-130 INTEGRAL FUEL TANK WING

Northrop Corporation
Aircraft Division

September 1972

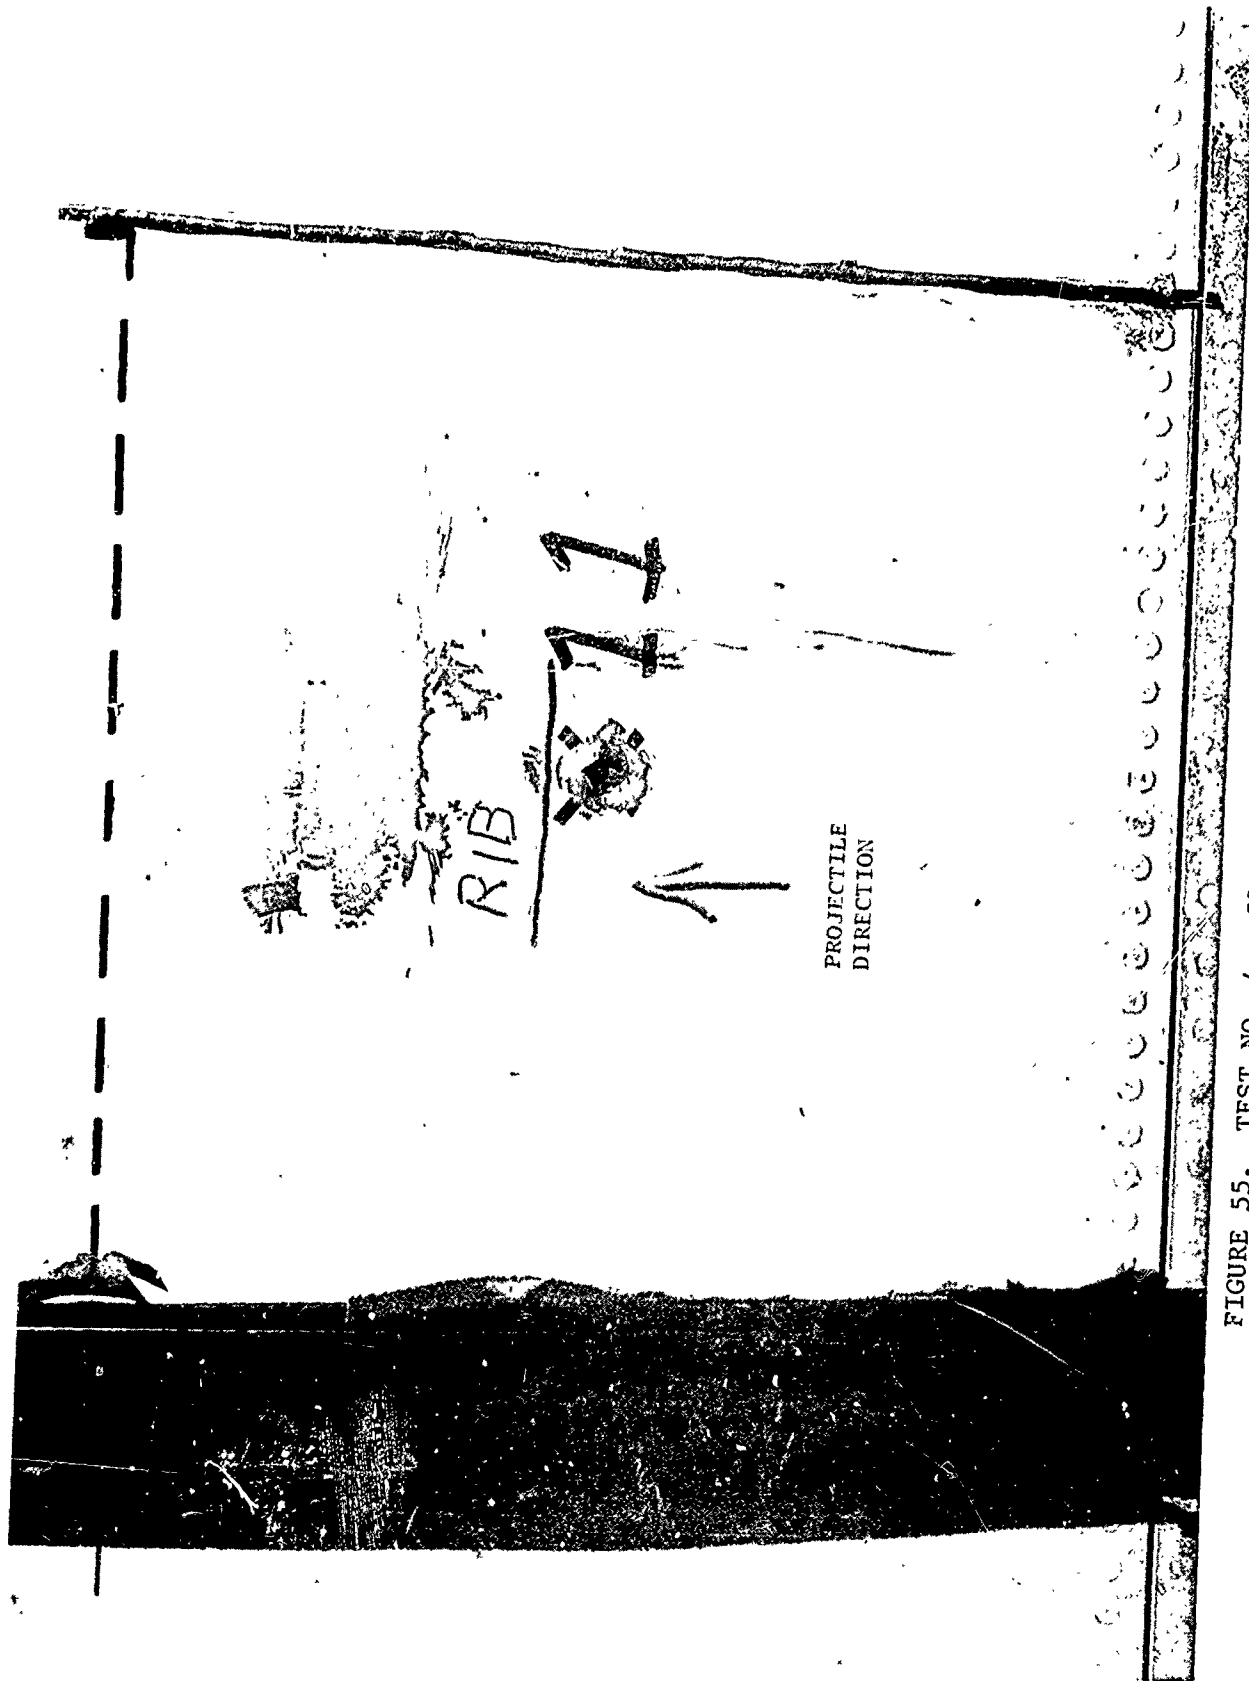
FIGURE 55. TEST NO. 4, .50 CALIBER AP, 45° FROM VERTICAL -
ENTRY FACE OF THE TANK

At entry, the projectile hit a rib laterally and ruptured it. Some deformation occurred at the entry hole due to the 45° angle impact (see Figure 55). The plain laminate behind the entry wall showed minor damage as is illustrated in Figure 56. The leakage measured was approximately 130 cc/min. This leakage reduced to about 70 cc/min. about 45 minutes after the shot. At the exit side of the tank, the projectile hit the metal skin in a slightly tumbled position, ruptured one rib, and bent another. The corrugated

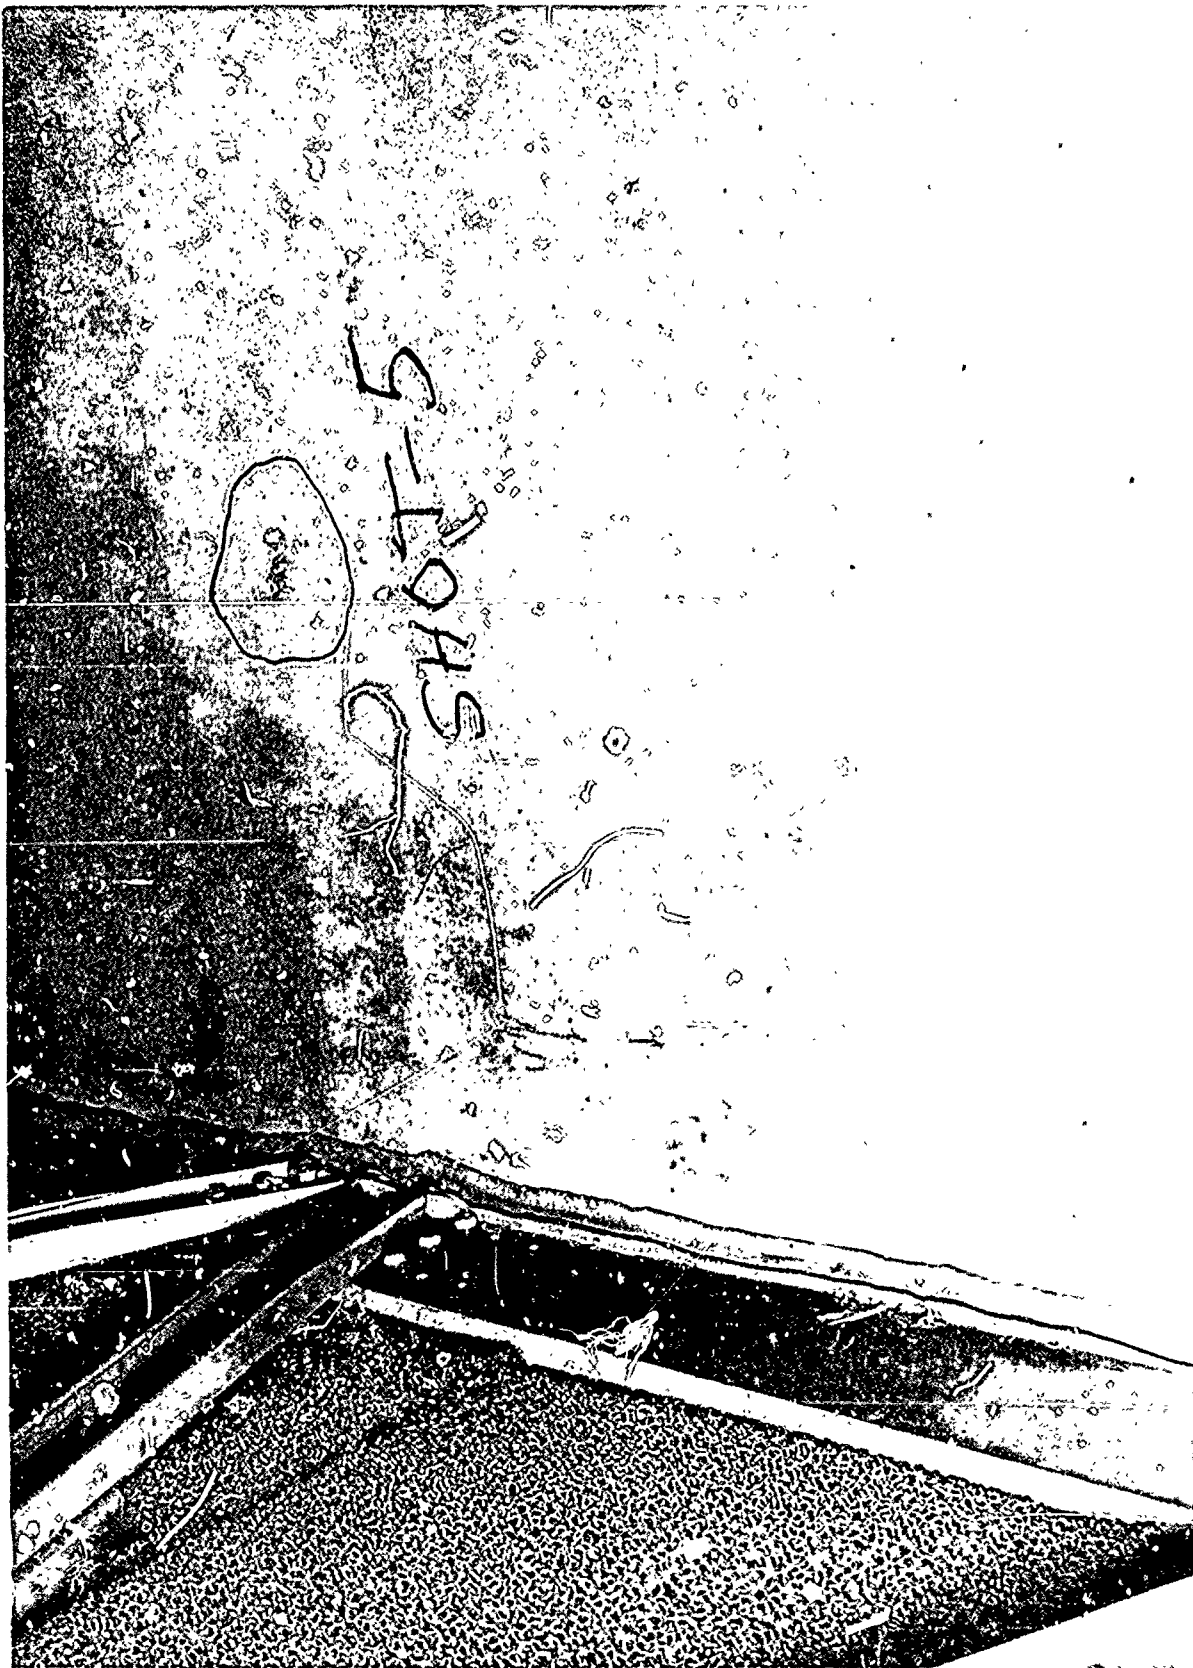
FIGURE 59. TEST NO. 5, .50 CALIBER AP, 45° FROM VERTICAL -
PLAIN LAMINATE BEHIND THE ENTRY WALL

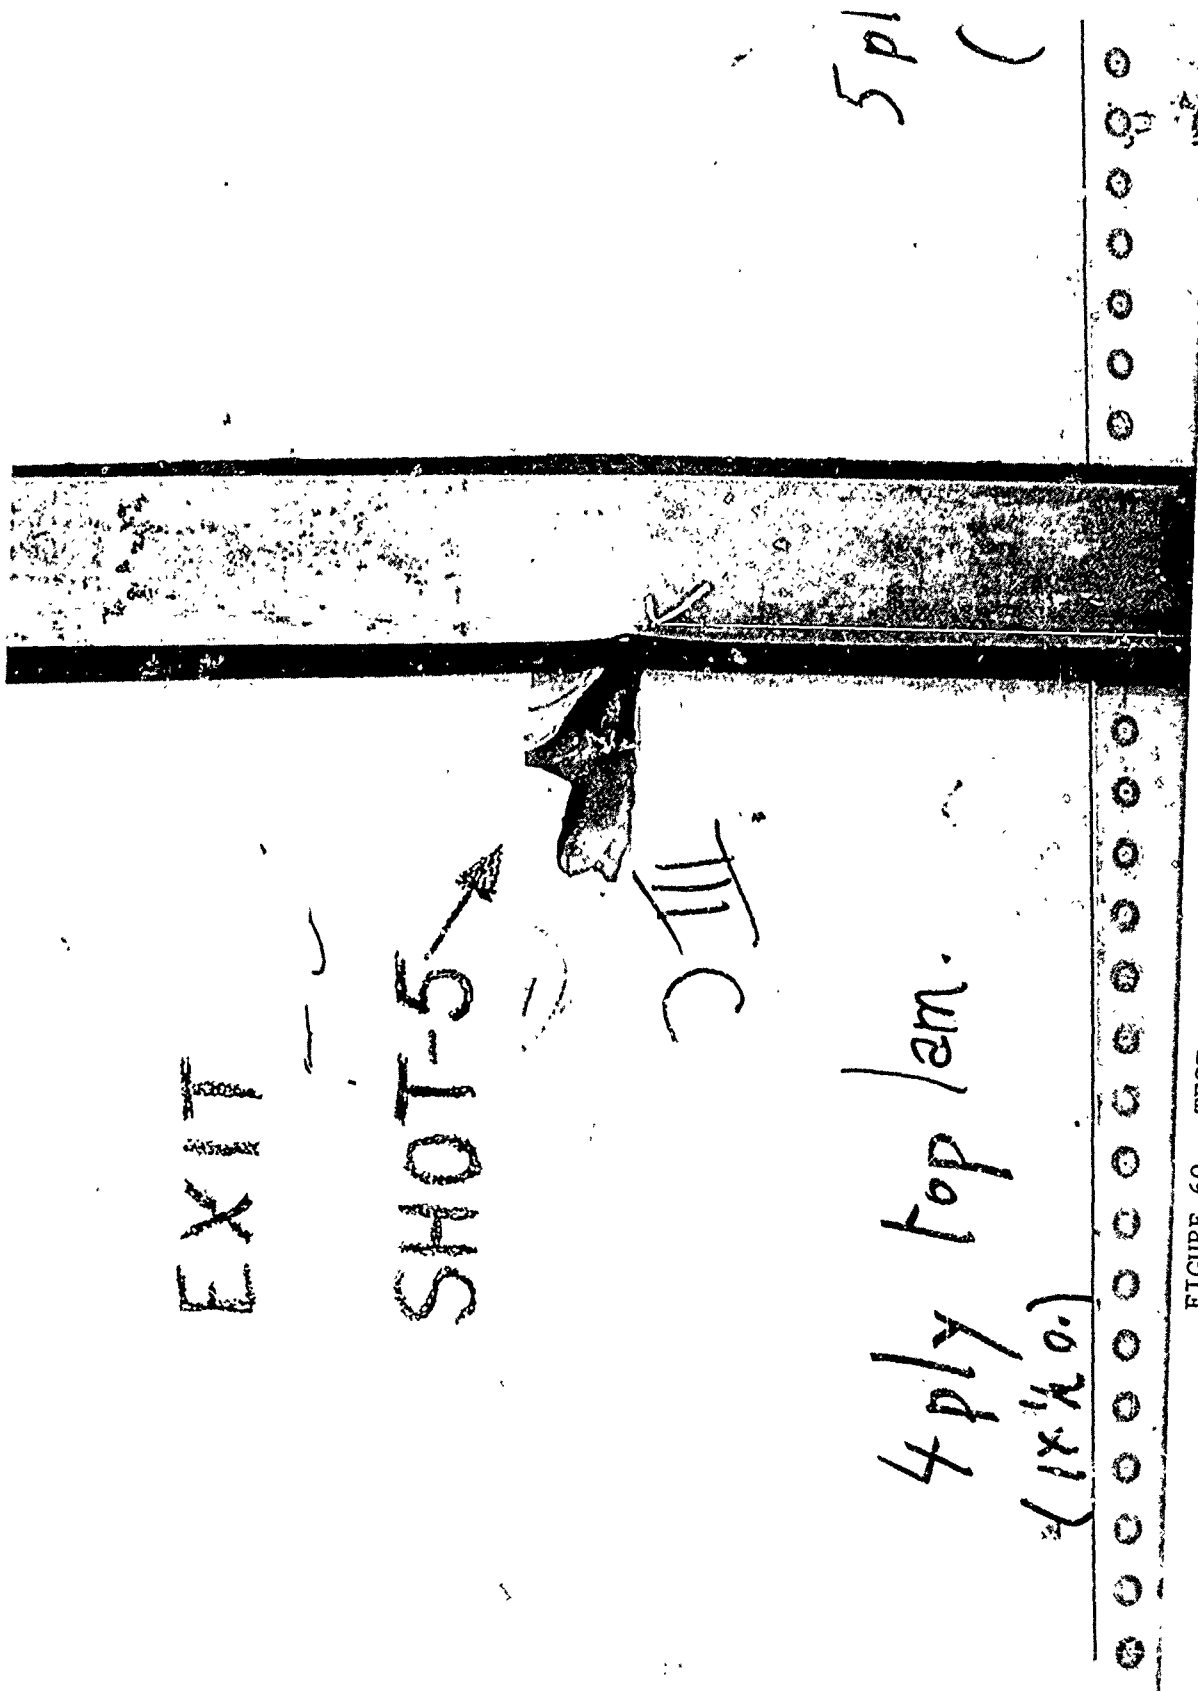
FIGURE 60. TEST NO. 5, .50 CALIBER AP, 45° FROM VERTICAL -
EXIT FACE OF THE TANK

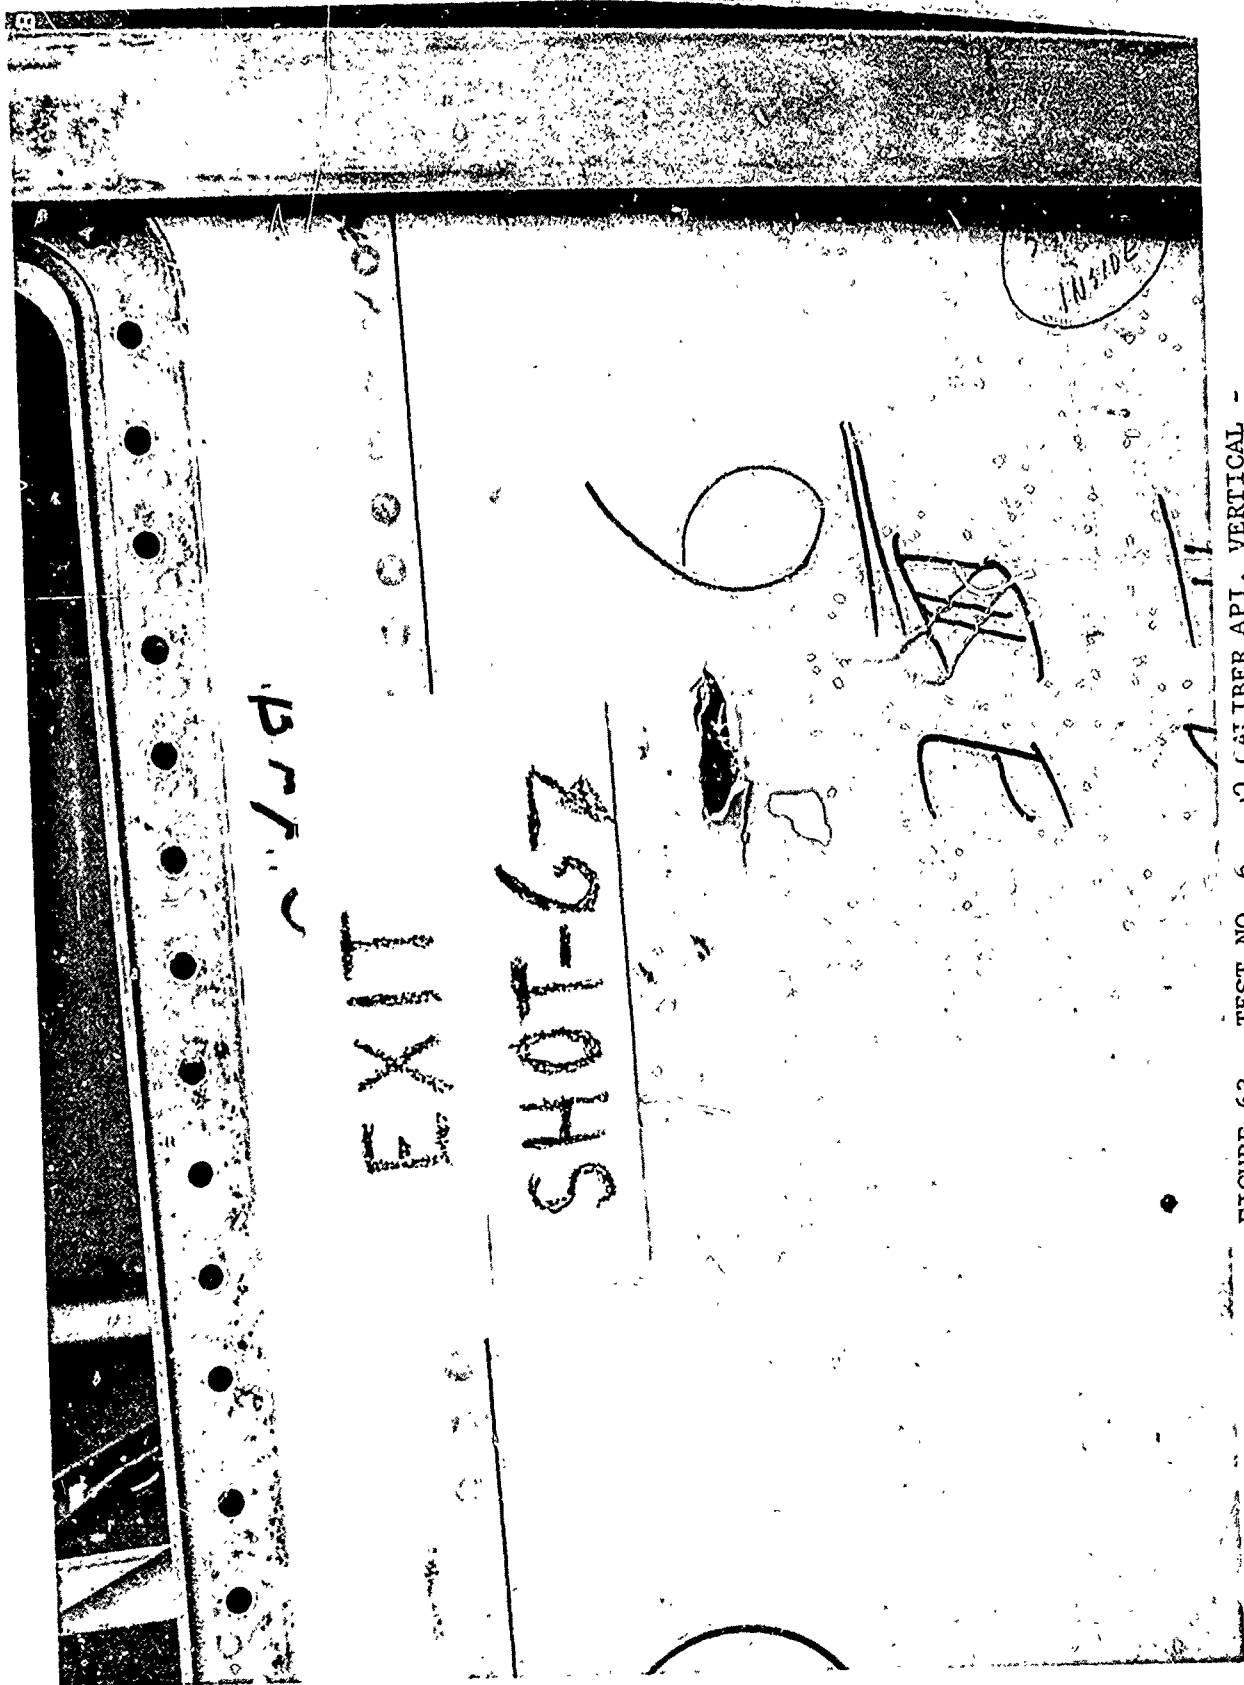
FIGURE 63. TEST NO. 6, .50 CALIBER API, VERTICAL -
EXIT FACE OF THE TANK

This is evident in Figure 63; the four-ply laminate behind the metal skin showed a 1 1/4-inch long slit. A 2-inch X 1/2-inch metal piece the size of the .50 caliber projectile was removed from the skin structure. No ribs were hit by the projectile. From the high-speed motion pictures taken and observations during the shot, it was established that functioning of the API projectile took place after the projectile had exited the tank. The points of entry and exit and the path of the projectile through the tank are given in Figure 48.

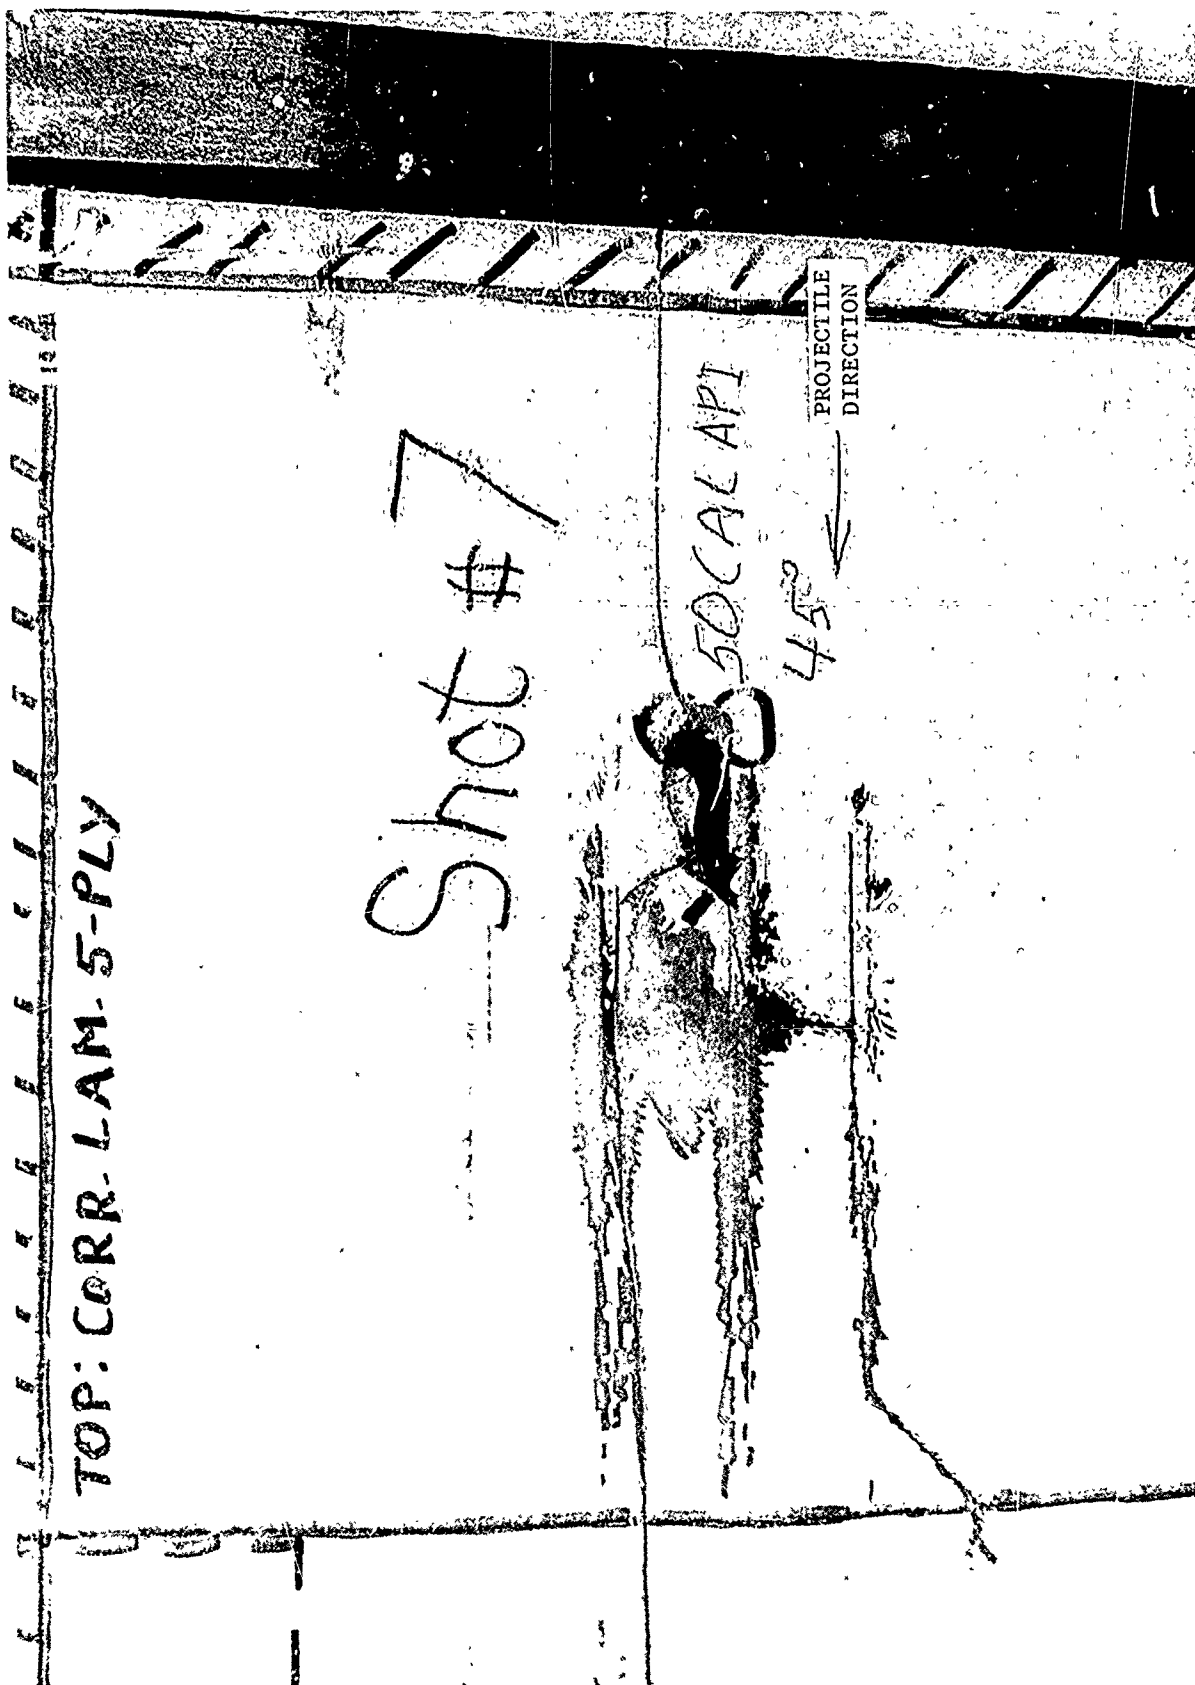
FIGURE 64. TEST NO. 7, .50 CALIBER API, 45° FROM VERTICAL -
ENTRY FACE OF THE TANK

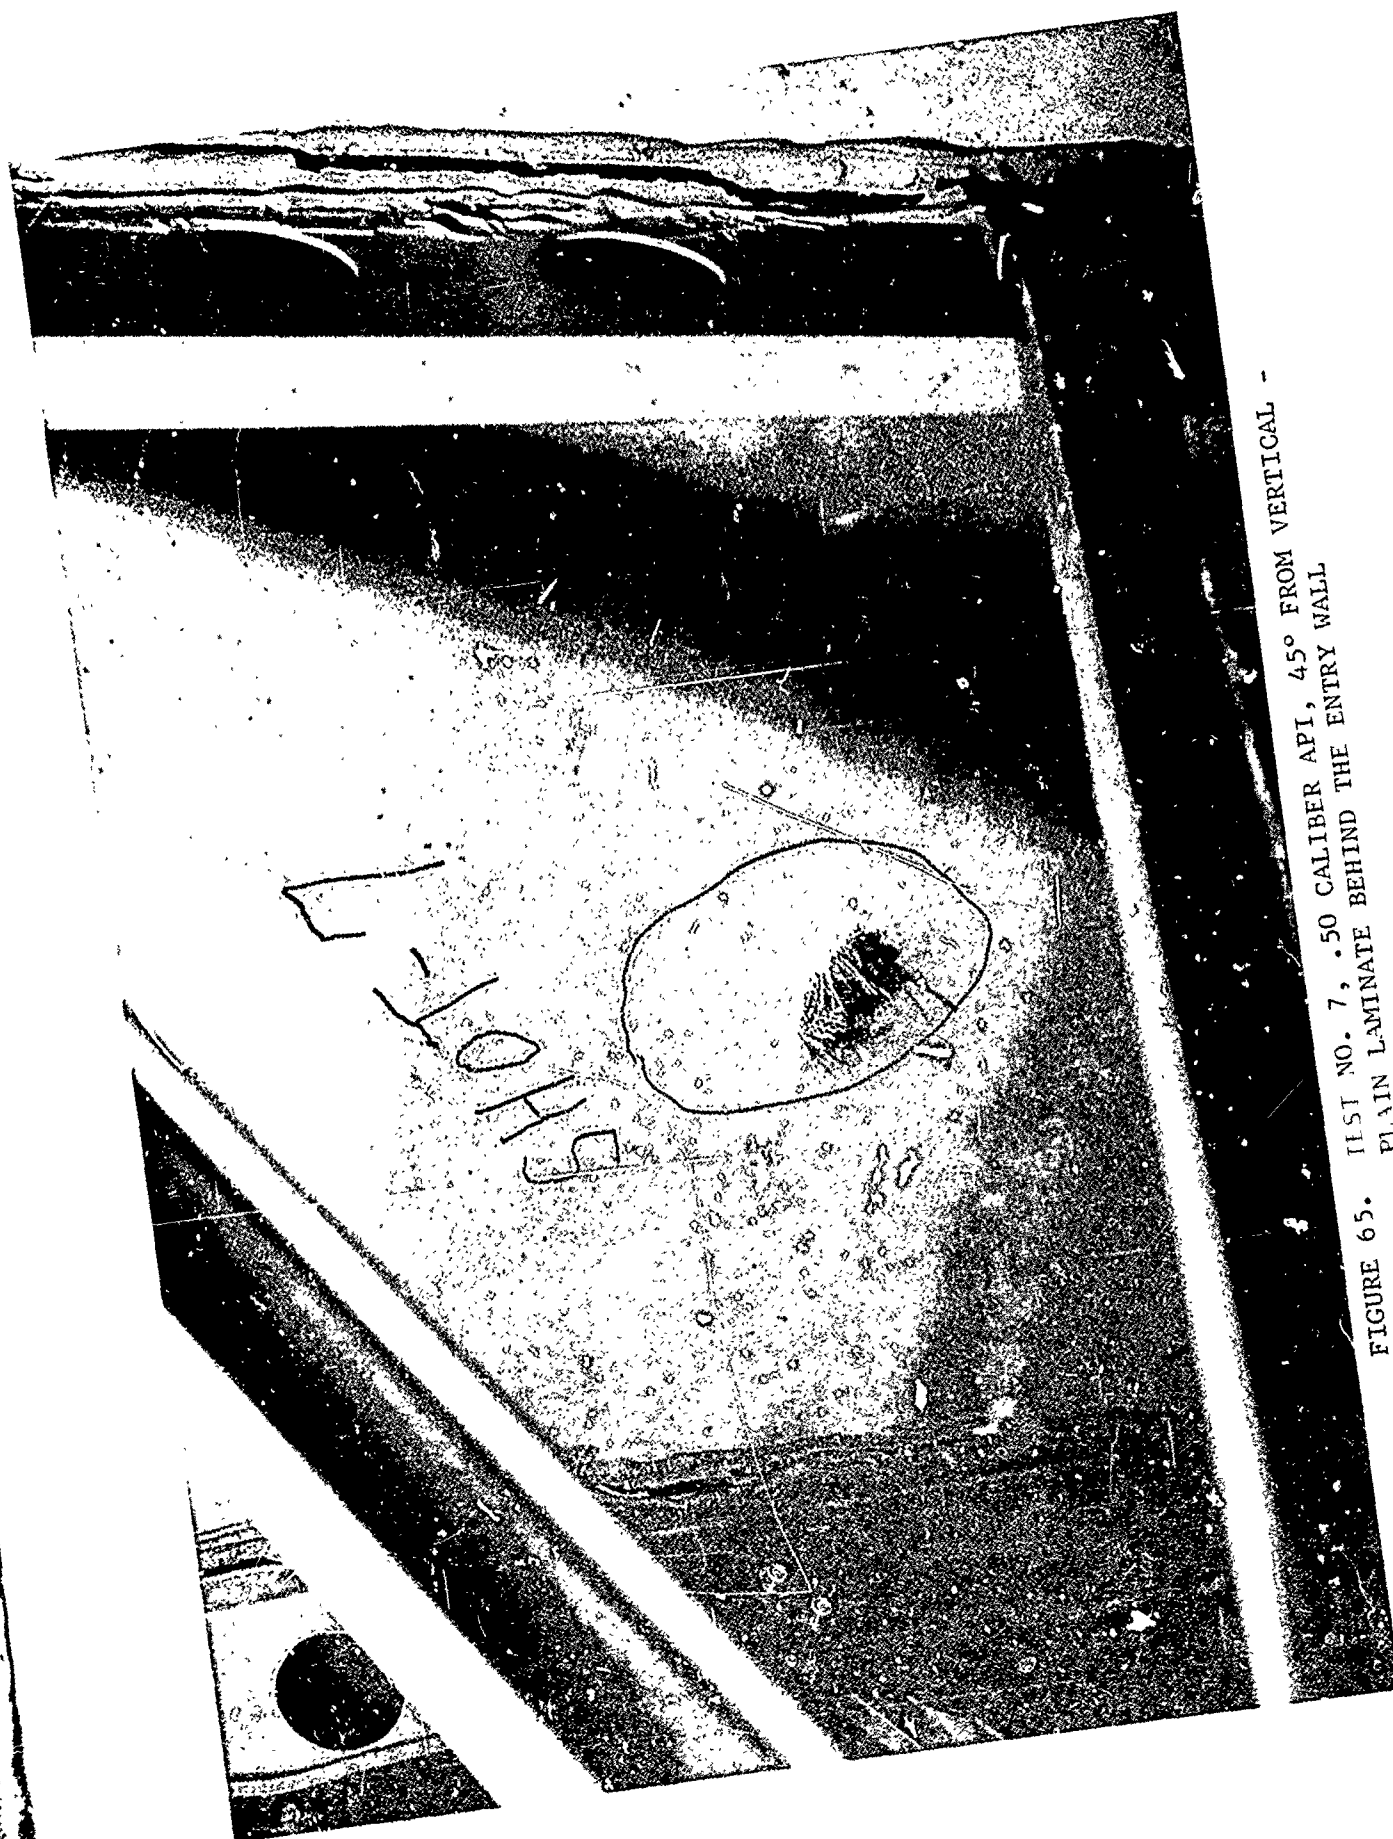
FIGURE 65. TEST NO. 7, .50 CALIBER API, 45° FROM VERTICAL -
PLAIN LAMINATE BEHIND THE ENTRY WALL

The projectile penetrated the tank in a 45° angle and hit a rib longitudinally. This made the API projectile function immediately behind the entry metal skin. This was evident on the high-speed motion pictures, from the burned area in the vicinity of the entry hole, and observations made during the test. The projectile tumbled immediately upon entry. This combination of the projectile hitting a rib and functioning and tumbling immediately behind the entry wall produced the high pressure ram waves which were responsible for the damage shown in Figure 64. A major crack, 47 inches long, and minor cracks in the vicinity of the impact hole, occurred as shown on the figure. The damage to the plain laminate behind the entry metal skin indicates the tumbling of the projectile and the cracked rib (Figure 65). The tear in the laminate measured 1 inch X 1/2 inch. The leakage was 3 liters/min.

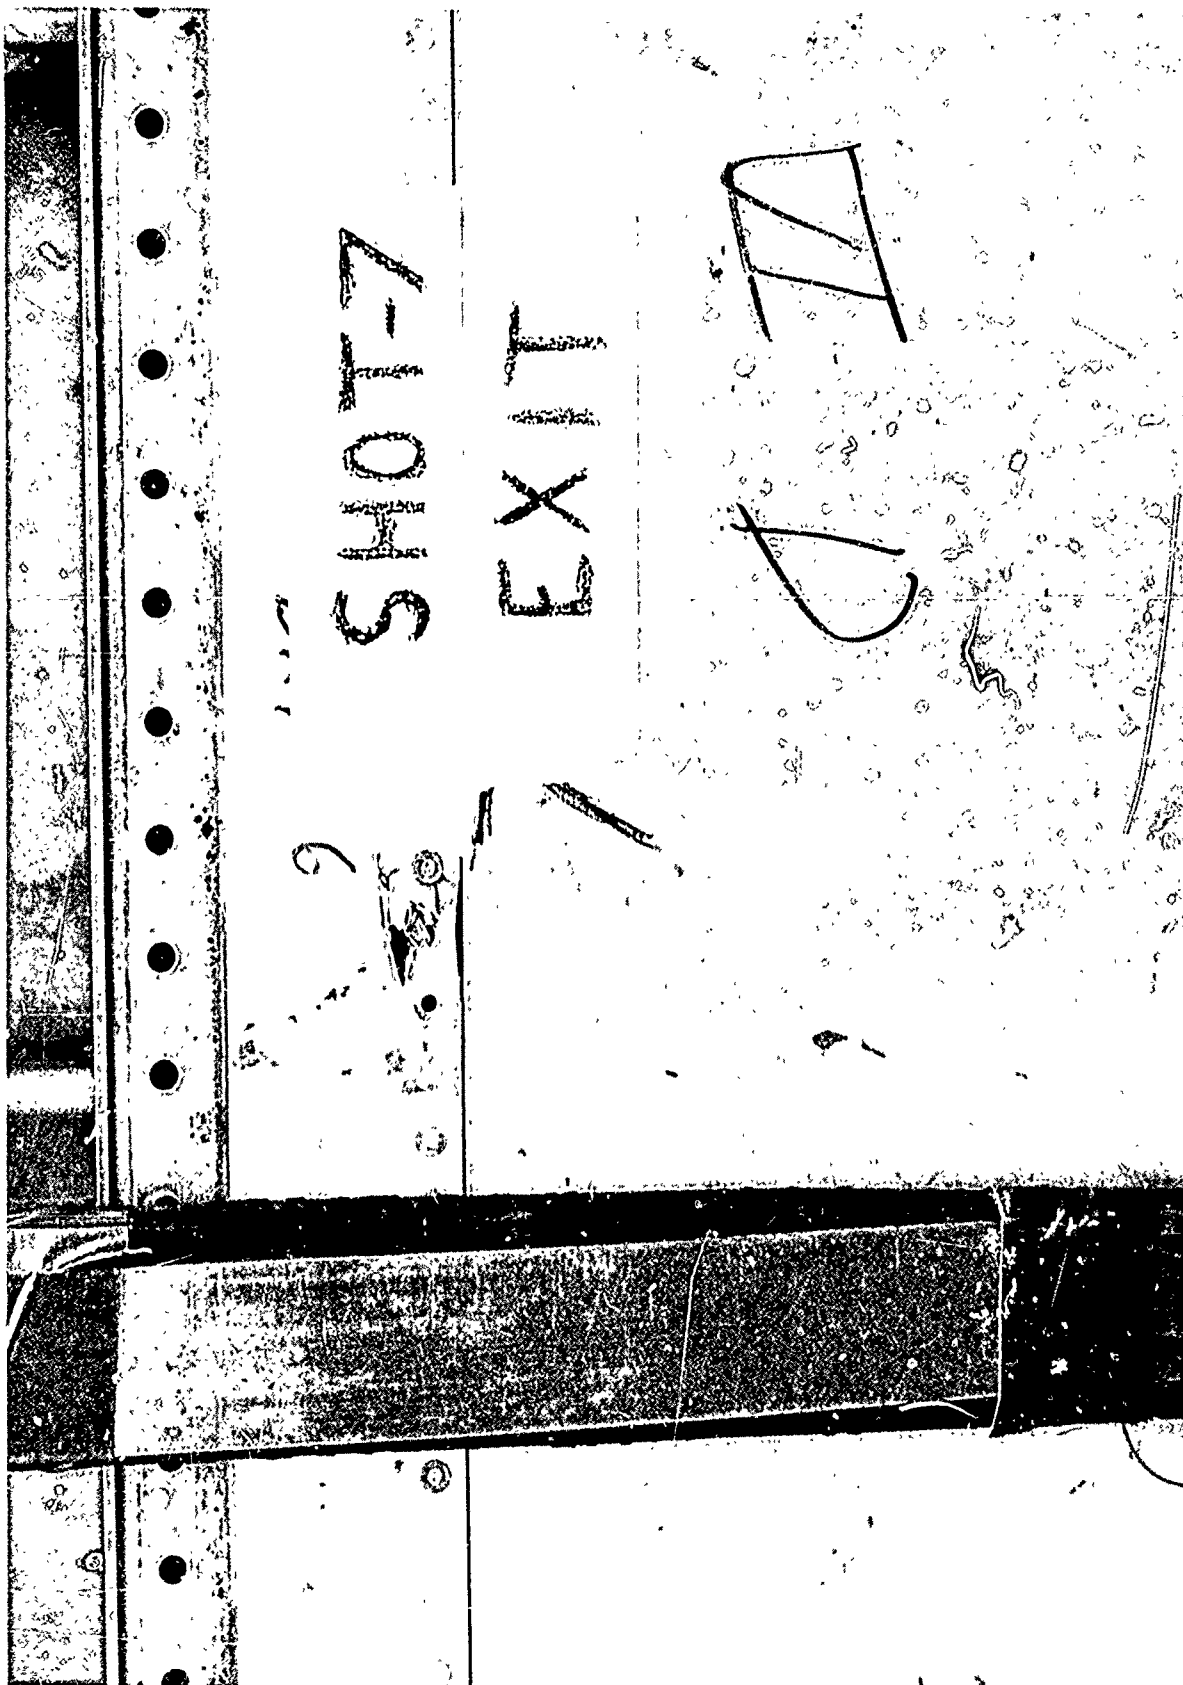
FIGURE 66. TEST NO. 7, .50 CALIBER API, 45° FROM VERTICAL -
EXIT FACE OF THE TANK

At the exit, the projectile brushed a rib and hit a row of rivets, which apparently ruptured the projectile, and only pieces of the projectile exited the tank as it is shown in Figure 66. The corrugated laminate bonded behind the exit wall skin kept the damage low.

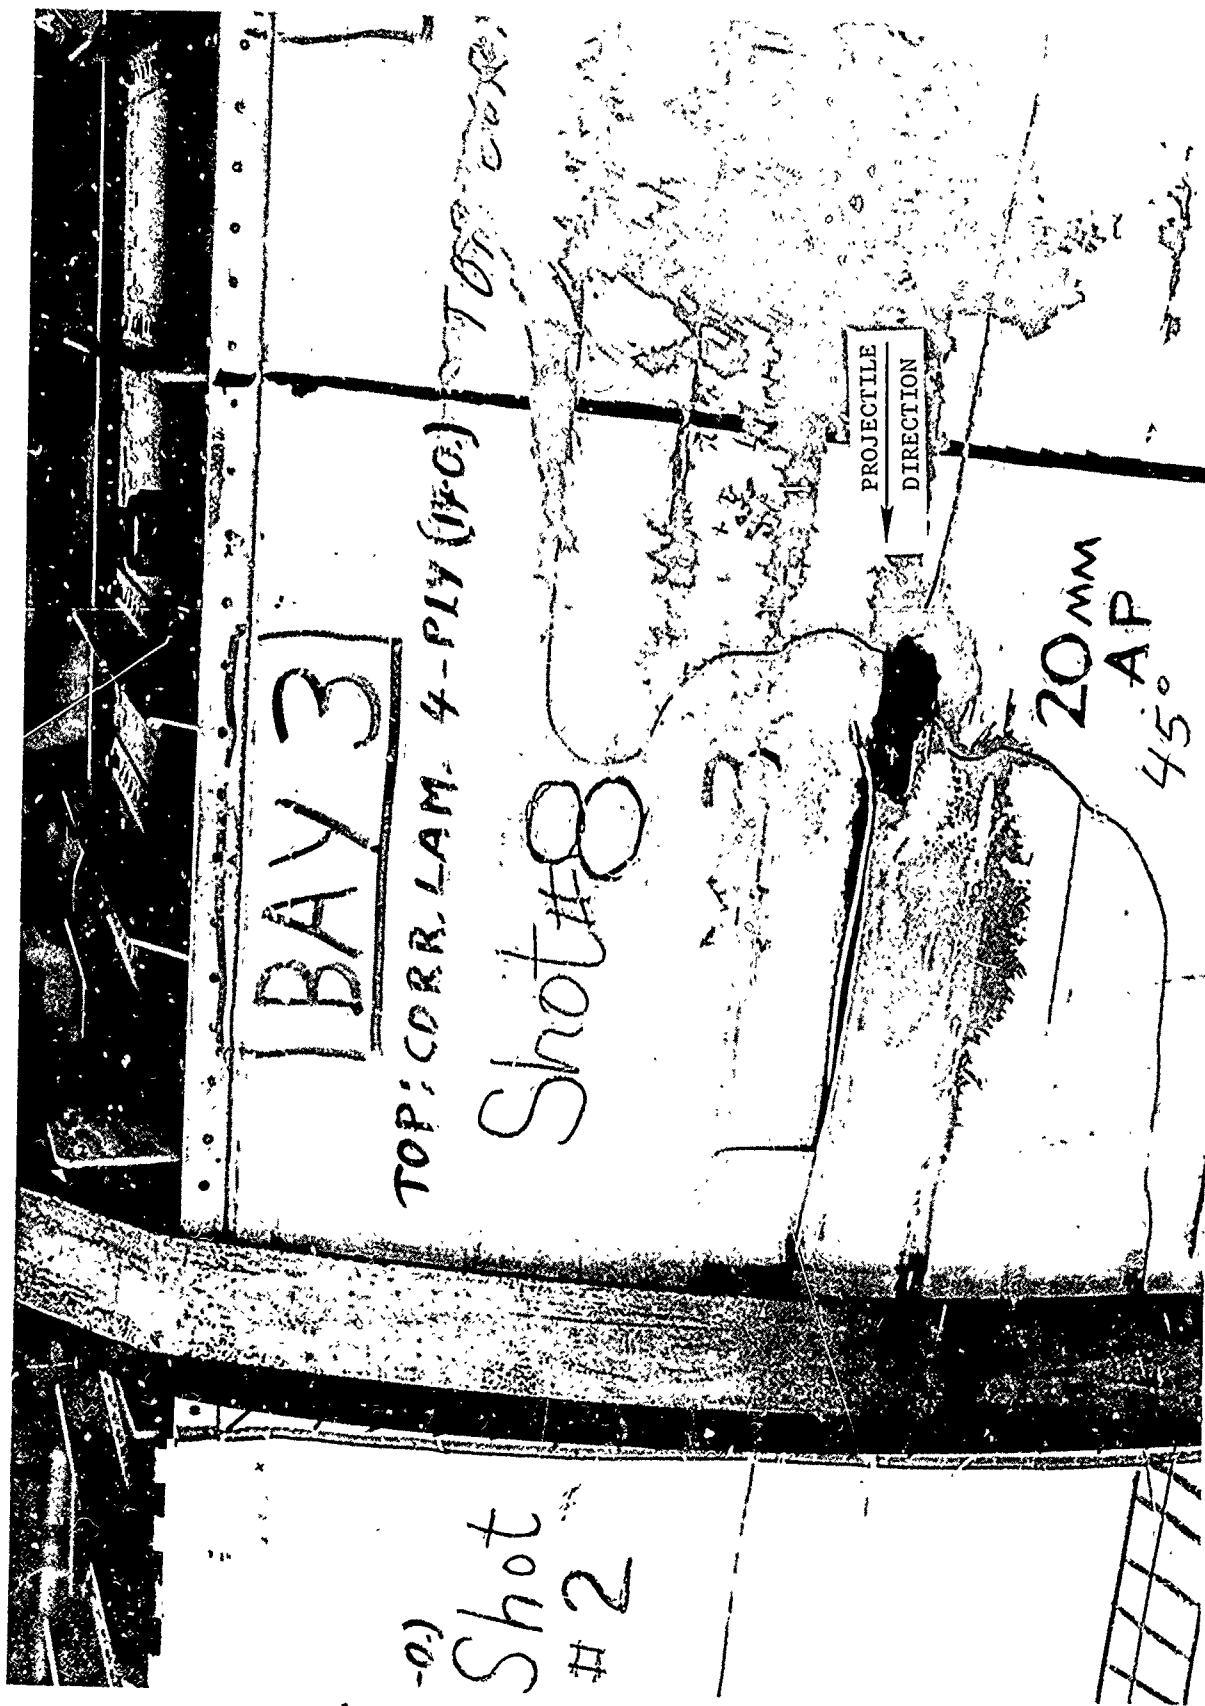
FIGURE 67. TEST NO. 8, 20MM AP, 45° FROM VERTICAL -
ENTRY FACE OF THE TANK

over several bays surrounding the impact area. This occurred immediately after impact and was witnessed in the high-speed films. This pressure phenomenon was responsible for the cracking of the tank entry skin as shown in Figure 67. Four major radial cracks occurred. The largest measured approximately 40-inches. The rib, which was hit by the projectile at the entry, was ruptured.

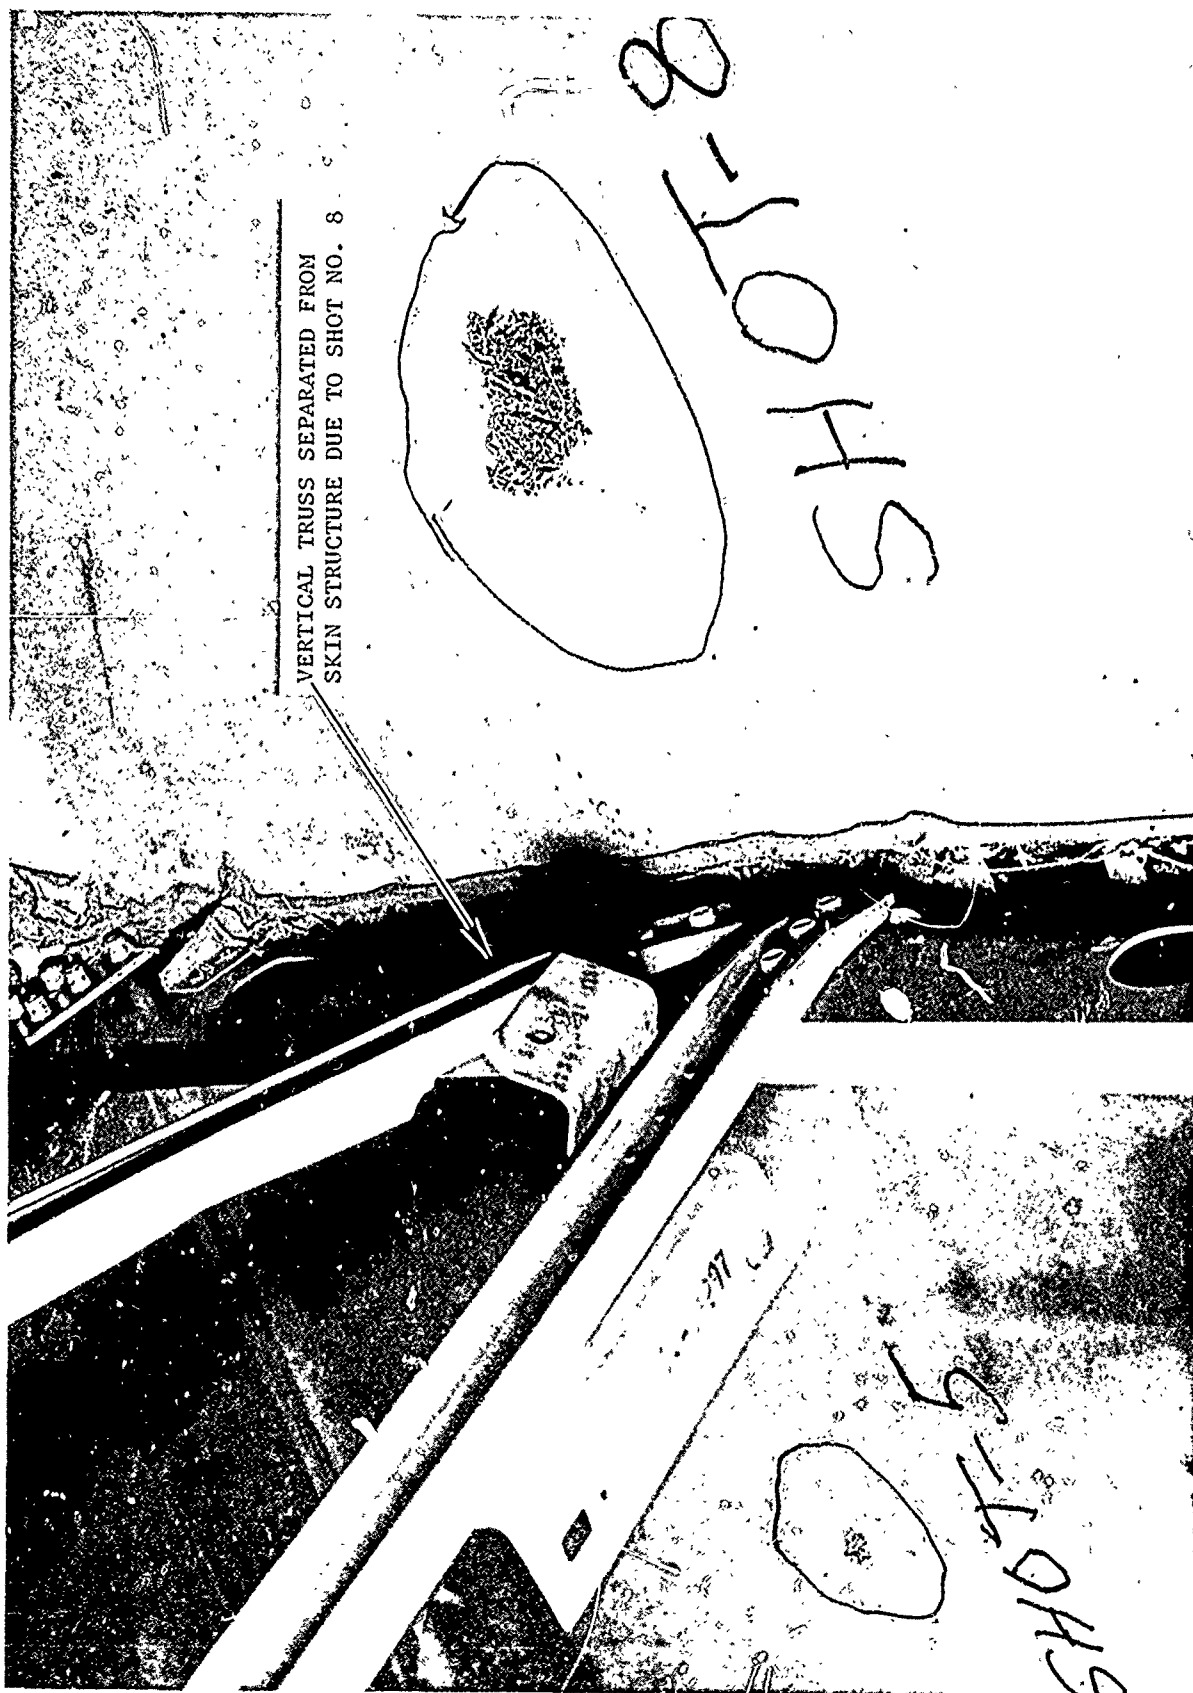
FIGURE 68. TEST NO. 8, 20MM AP, 45° FROM VERTICAL -
PLAIN LAMINATE BEHIND THE ENTRY WALL

The corrugated laminate behind the cracked skin showed only a 1 3/4-inch rip, and the precompressed foam had reduced the projectile entry hole to approximately 1/4 inch. The plain laminate behind the entry metal skin showed minor damage (a 1 1/2-inch X 3/4-inch rip) in the area where the 20mm. projectile penetrated (see Figure 68). However, the adjacent vertical trusses, as shown in Figures 68, 50 and 53, were separated from the skin structure. This uncovered an area of the skin structure which did not have any protection. When the installation of the self-sealing system was performed, this area of the tank structure was inaccessible and no self-sealing protection could be installed. The major leakage was thus due to this separation of the trusses from the skin. The fuel infiltrated through this unprotected area and leaked out of the skin cracks. The leakage measured was approximately 7 liters/min.

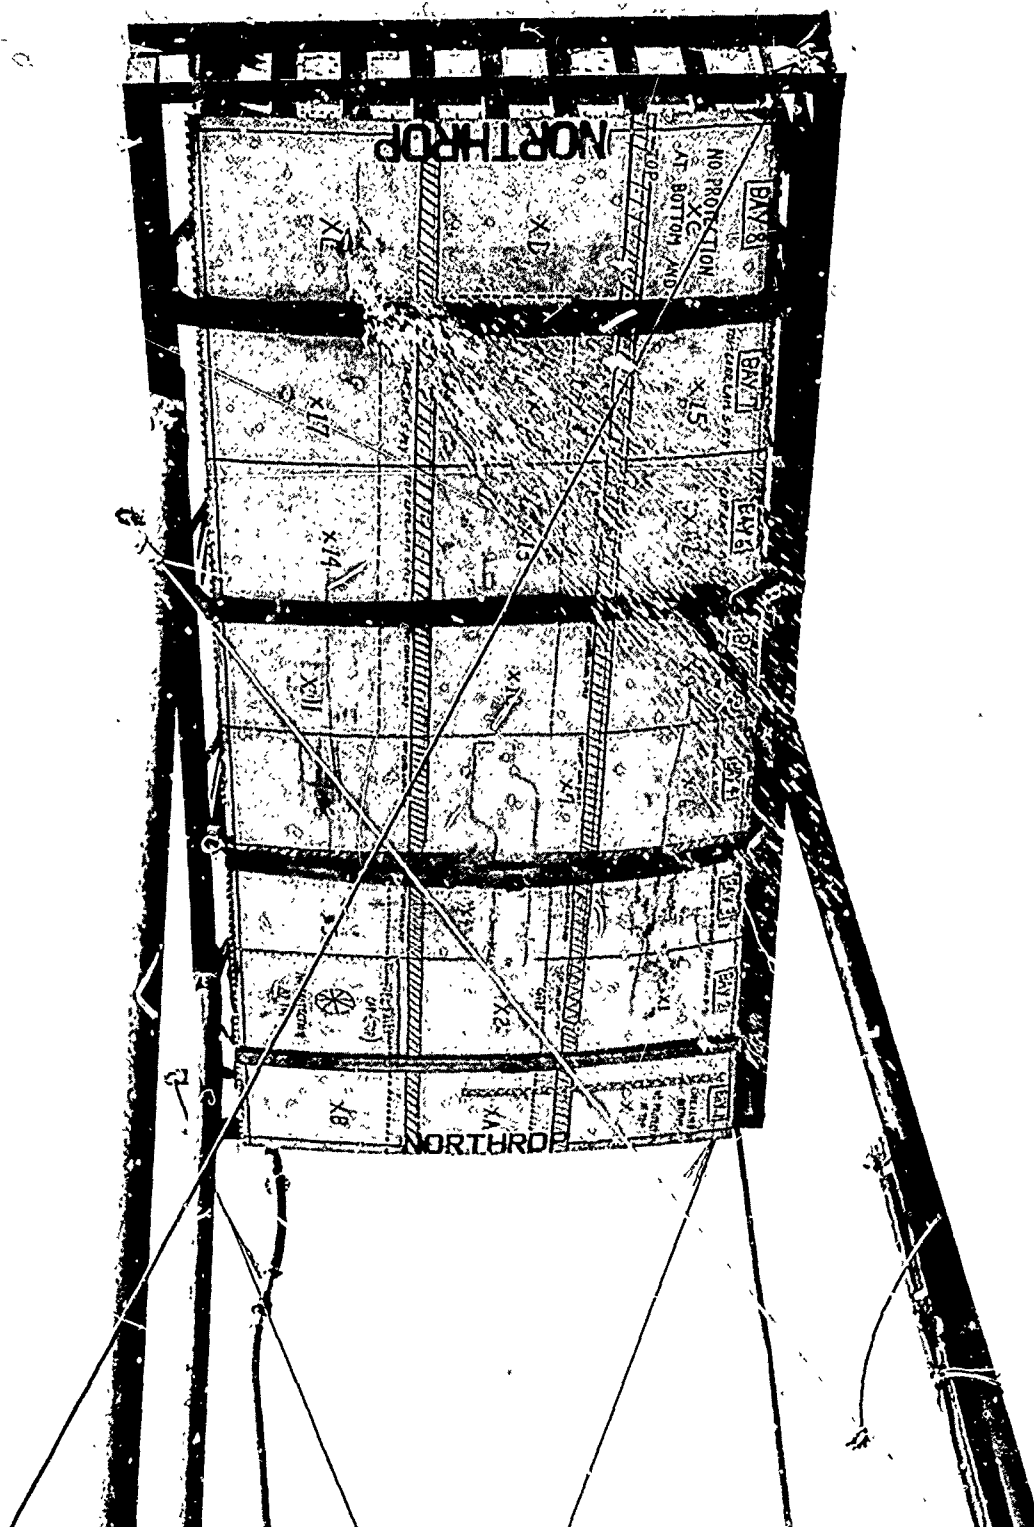
FIGURE 70. TEST NO. 9, .50 CALIBER AP, 45° FROM VERTICAL -
LEAKAGE OF FUEL AFTER IMPACT

For comparison purposes, a .50 caliber AP projectile was fired into Bay 8 (area X E) which did not contain any protection. That is, no damage control or self-sealing systems had been installed in this part of the tank. The projectile impacted the tank in a 45° angle of incidence. Figure 70 shows the fuel leakage immediately after impact. The leakage was too heavy to be measured. The damage at the tank entry metal skin is shown in Figure 71. A hole 2 1/4-inch X 3/4-inch and two cracks (6 inches and 16 inches long) were provoked as shown in the figure. Upon penetration of the tank entry wall, a rib was hit. At the exit side of the tank, the tumbling projectile hit two ribs including one with rivets. A 5-inch x 2 1/2-inch piece of metal was removed and there were cracks in the skin around the hole (See Figure 72).
